**Bongo Development Organization**

# REPORT ON LATRINE INSTALLATION IN BONGO DISTRICT, UER, GHANA

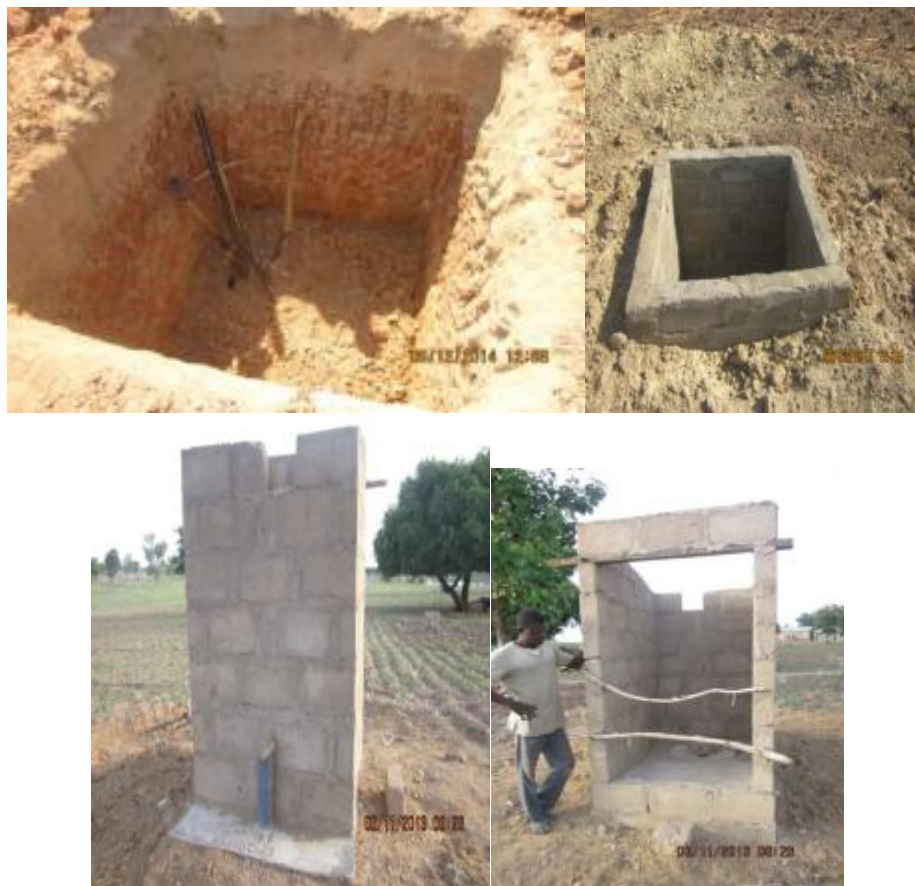
**Figure 2 Stages of Latrine Construction**

The latrine design that was adopted is the KVIP pit latrine. It has a single pit with a width of 8 feet and a diameter of 6 feet (3 feet radius) and a squat hole. The design was appropriate for the large household size (averaging 6). However, each of the household beneficiaries are contained in large extended family compound houses and are more likely to share the facility with other households in the compound houses.

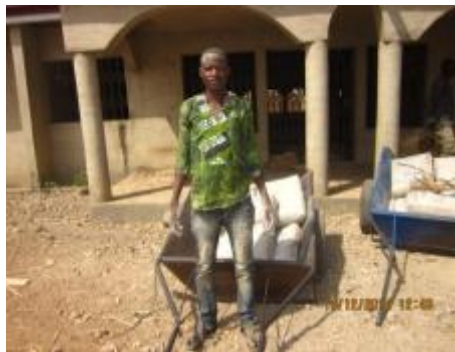
**Figure 3 Materials being delivered**

The project provided three major materials to beneficiaries that otherwise would have made it impossible for them to have household latrines. For effective and timely delivery, Lahaad Enterprise in Bolgatanga supplied the required material to the communities and that met donor's obligations to supplying cement, vent pipe and roofing sheet. Each beneficiary received 8 bags of cement, 1 vent pipe and 2 aluminium roofing sheets. Besides, the beneficiaries also provided adequate local materials that include washed sand, stones and water in addition to wood and roofing nails.

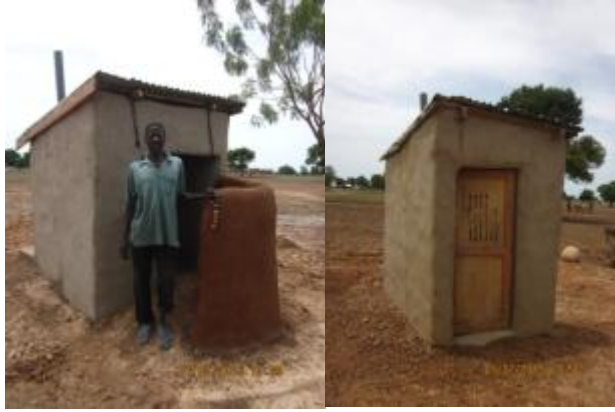
**Figure 4 Completed Latrines**

The substructures of the 20 latrines are then completed and covered with slabs. The superstructure was also completed and roofed and in use.
